USMC MRAP MISHAP TRENDS 2008 TO 2010

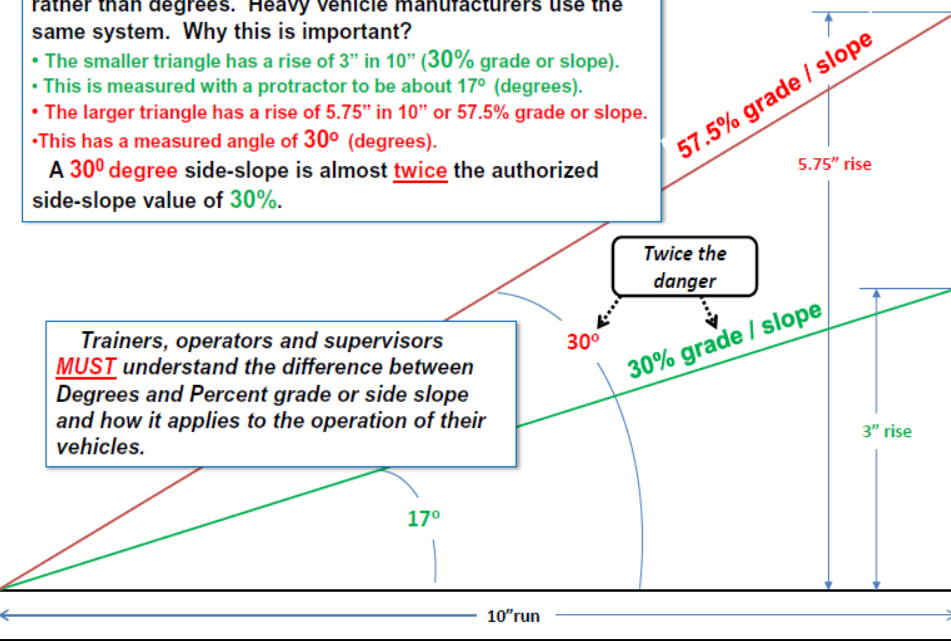
Comparison of Side-Slope Values in % vs. degrees (°)

- The smaller triangle has a rise of 3" in 10" (30% grade or slope).
- This is measured with a protractor to be about 17° (degrees).
- The larger triangle has a rise of 5.75" in 10" or 57.5% grade or slope.
- This has a measured angle of 30° (degrees).

A 30° degree side-slope is almost twice the authorized side-slope value of 30%.

Trainers, operators and supervisors MUST understand the difference between Degrees and Percent grade or side slope and how it applies to the operation of their vehicles.
